K-642

Sunday School of Trinity Methodist Church, South

Millington

State Historic Sites Inventory Form

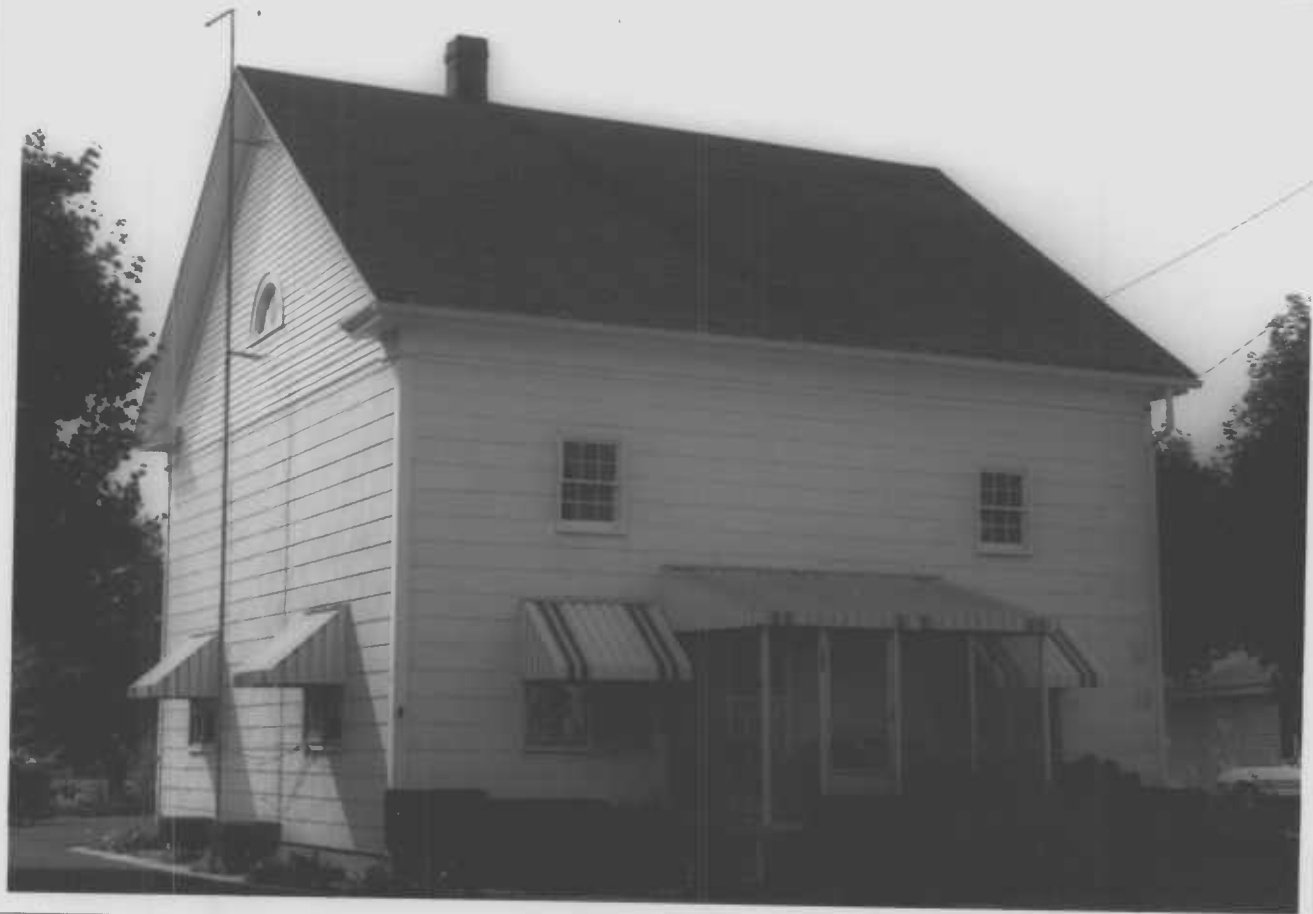
1C 472-33

Sunday School of Trinity Methodist
Episcopal Church, South, Sassafras St.

View to northwest

The ca. 1918-1920 frame, gable-roofed Sunday School building of the now-gone Trinity Methodist Episcopal Church, South, is located on the west side of Sassafras Street near the northern edge of Millington. Its roof ridge parallel to the street, the building is almost square, though the gable ends are slightly deeper than the street facade is wide. With its tall walls the usual height of a two-story building and second-story windows now in place the building appears to be two-story. However, as built, the building was one-story in use, with the space open in each of the four nearly equal rooms from entry level to the height of the present second-story ceiling level. On the lower level the rooms were said to have been divided from each other by only posts and heavy curtains. The upper partition walls seem to have been fully framed and plastered, and each of the four ceilings finished with a handsome pressed-metal ceiling and cornice. During the conversion to a dwelling in 1951-1952 a floor was installed for the upper level thereby also creating a conventional-height ceiling for the lower level, and second-story windows were installed. Apparently there had been none originally. Only one of the now second-story rooms with the handsome ceilings and cornices is accessible, via a pull-down stair. The other three can be reached only from the exterior, through a window. A one-story kitchen addition, using in part the old facade vestibule, has been added to the rear. The Sunday School is said to have been connected by a double-doored hyphen on its north end (probably from the northwest room) to the south side of the church, which was perpendicular to the street. Despite its late date, the Sunday School's roof details and simple, bulky form cause it to resemble the vernacular Greek Revival middle-nineteenth century churches of Kent County. No one can now describe the style of the church itself, though the exterior was said to have been clad in horizontal, lapped weatherboard.

The original Sunday School building measured about 32 feet wide by 33-1/2 feet deep. It is three bays wide on the first story with the entry now in the center bay under a screened porch. The entry may have been elsewhere originally. There is some concrete pavement to the west of the town pavement remaining in front of the north half of the building. There is a small double-hung window with 6-over-6 lights in each side bay on the second story, but these are 1951-52 additions. There are three first-story windows on the north end, but their placement reflects the altered interior division of space in the north half of the building. A front and rear bedroom with a bathroom between were created from the two original north rooms. In addition, the north end was partially rebuilt after the hyphen was removed. The two second-story north-end windows were installed during the conversion; there are no south-end second-story windows. Indeed all the windows may be 1951-52 replacements or additions. There are no shutters.

The exterior walls are covered with asbestos shingles over the earlier cladding, except for the gables, which are of horizontal, lapped weatherboard that may or may not be original. There are double cornerboards of 5-3/4" x 1-1/8" material trimmed where they meet the cornice frieze with simple caps reminiscent of Greek Revival pilaster treatment. Although it is most likely that the original weatherboard was horizontal, under the bottom course of asbestos shingles the ends of vertical boards were felt and seen.

The roof is now covered with asphalt shingles. The cornice is boxed and trimmed with a crown with a profile of a cyma recta over a filleted cove. The bed molding is a cyma reversa on a deep (ca. 12"), plain frieze, which continues under the prominent returns (ca. 40"). The north end is trimmed slightly differently, with a fillet and ovolo bed on a narrow frieze board, indicating alterations on this end. The crown is very small and plain. Gutters have been installed.

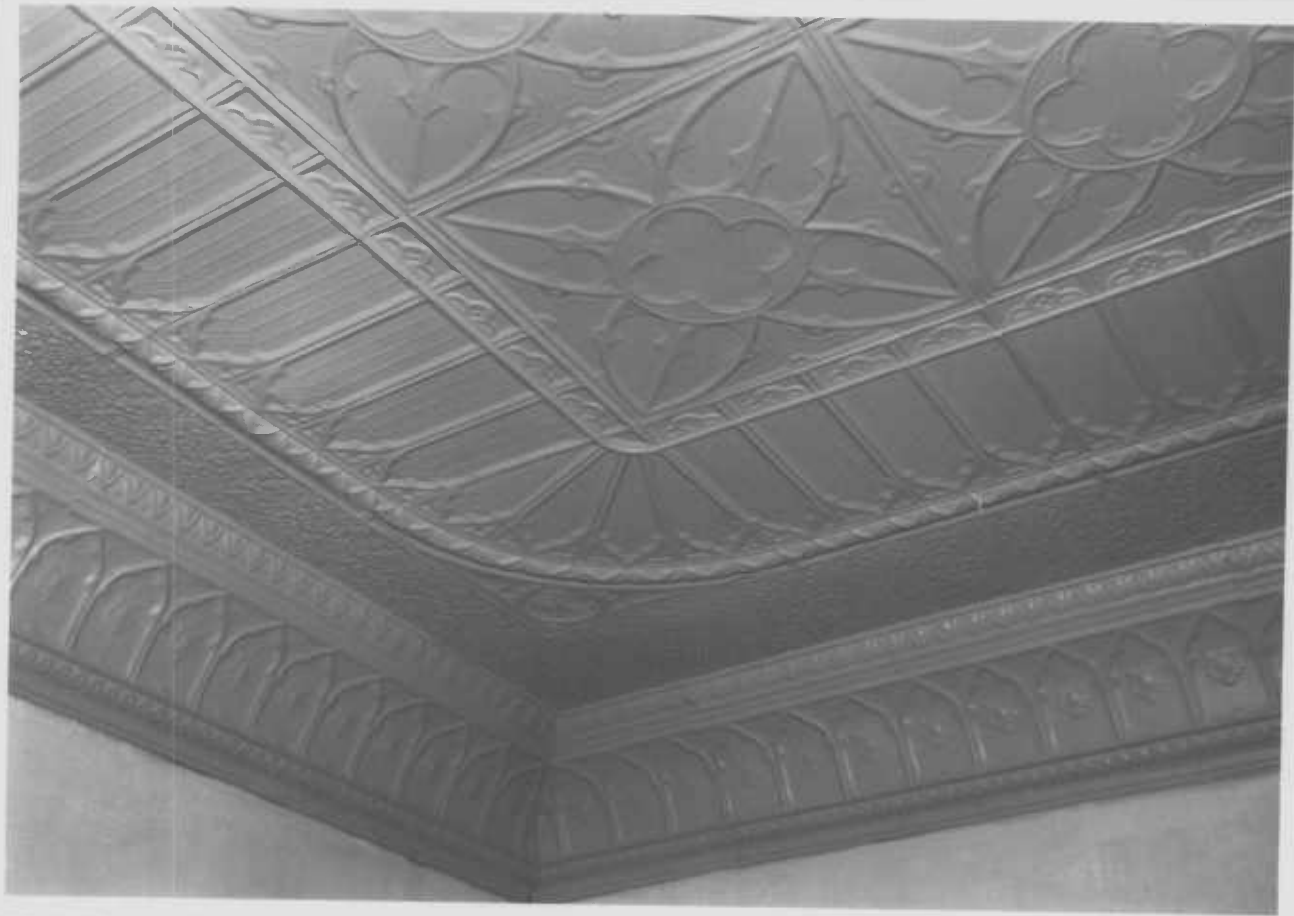
K 642-13

Sunday School of Trinity Methodist Episcopal
Church, South Sassafras St., Millington

Ceiling, 2nd story

View to southwest

The pressed-tin ceilings and curved cornices, now on the second-storey, are the most notable element of the Sunday School. Only the ceiling of the southwest room was seen and photographed; the other second-storey rooms are accessible only through their windows. The main, center ceiling is of 16 interlocking 24" squares with a double quatrefoil theme. The ceiling border employs a kind of Gothic arch theme. The cornice is ca. 16" deep and composed of various horizontally repeated elements. Included is egg-and-dart as well as another linear arch series, with shields within each arch. The design of the ceiling indicates that it was manufactured for use in church buildings. It was probably sold by suppliers of church furnishings. The ceiling and cornice now are painted light green; the owner of the house said they were peach-colored when she and her husband bought the house.
